Manhole Inspection Summary

Manhole # S02EE2003MH

Insp Date: **8/9/06 8:44 AM**

Location Address: **3315 Clarks Ln**

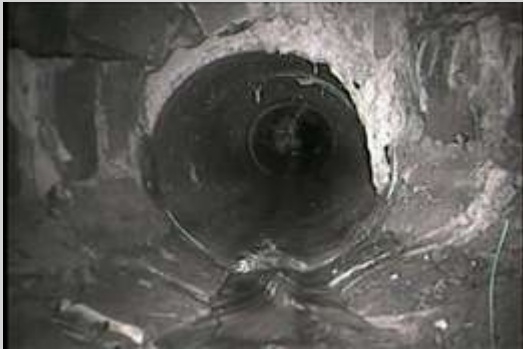
8 in. Circular Gravity Sewer Pipe Out @ 12 O'Clock

Pipe Material: **Clay** ☐ Pipe Lined

Invert Depth: **11.00** (ft.) Flow Characteristics: **Slow**

Deposits: ☒ None ☐ Mud ☐ Sludge ☐ Debris ☐ Grease

Infiltration: **None** Pipe Seal Cond: **Sound**

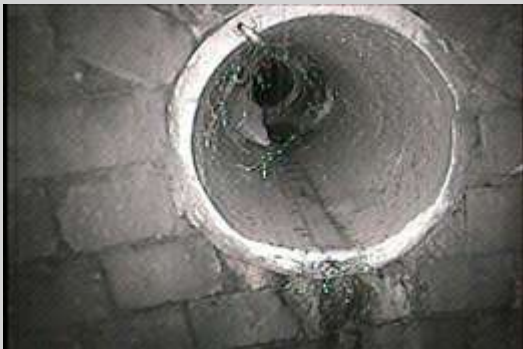
8 in. Circular Gravity Sewer Pipe In @ 3 O'Clock

Pipe Material: **Clay** ☐ Pipe Lined

Invert Depth: **6.80** (ft.) Flow Characteristics: **Slow**

Deposits: ☒ None ☐ Mud ☐ Sludge ☐ Debris ☐ Grease

Infiltration: **None** Pipe Seal Cond: **Sound**

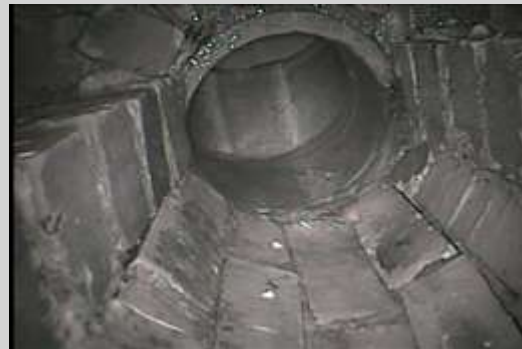
Drop In @ 3 O'Clock

Drop: **Outside** Rod and Bar
Angled: **Yes** Reading: **9.55** (ft.)
Inv Depth: **10.55** (ft.)

Drop Condition: **Partly Clogged**

Connects To: **House connection / Service line**

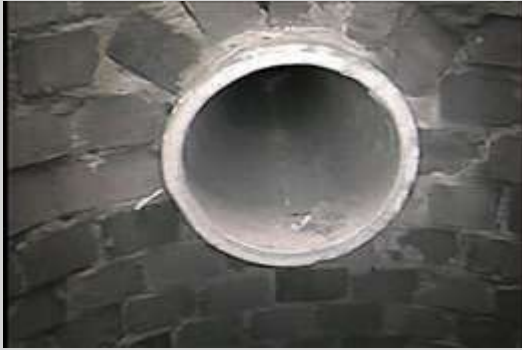
8 in. Circular Gravity Sewer

Pipe Material: **Clay** ☐ Pipe Lined

Invert Depth: **3.65** (ft.) Flow Characteristics: **Slow**

Deposits: ☒ None ☐ Mud ☐ Sludge ☐ Debris ☐ Grease

Infiltration: **None**

Pipe Seal Cond: **Sound**

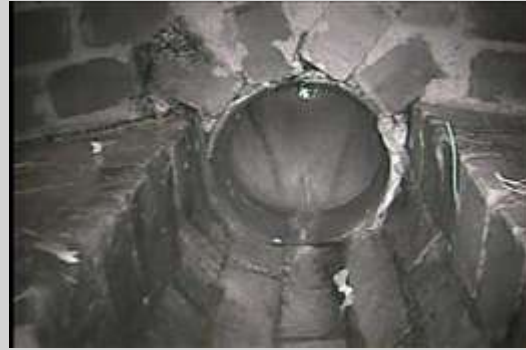
Drop In @ 6 O'Clock

Drop: **Outside** Rod and Bar

Angled: **Yes** Reading: **9.50** (ft.)

Inv Depth: **10.50** (ft.)

Drop Condition: **Open**

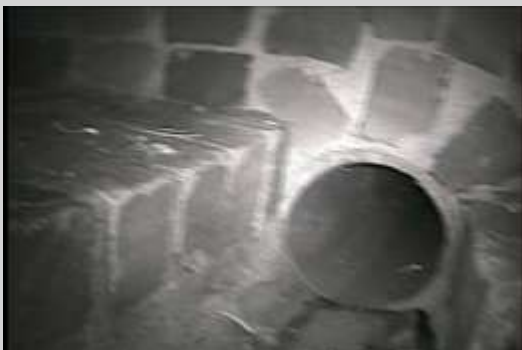
6 in. Circular Gravity Sewer

Pipe Material: **Clay** ☐ Pipe Lined

Invert Depth: **10.65** (ft.) Flow Characteristics: **Slow**

Deposits: ☒ None ☐ Mud ☐ Sludge ☐ Debris ☐ Grease

Infiltration: **None**

Pipe Seal Cond: **Sound**
